SAPAPALEI ROAD SURVEY
55-13-41 TO 163
BOOK II (P. K. TO BS)

SURVEY NOTES: SS-13-91 to 92, 98 to 163, AND PP-K to BS
SAPAPALII ROAD SURVEY / SAUAI, WESTERN SAMOA / BOOK II.
20.12.76 — 14.1.77

FAASAKELEAGA DISTRICT

SAVAI'I, WESTERN SAMOA

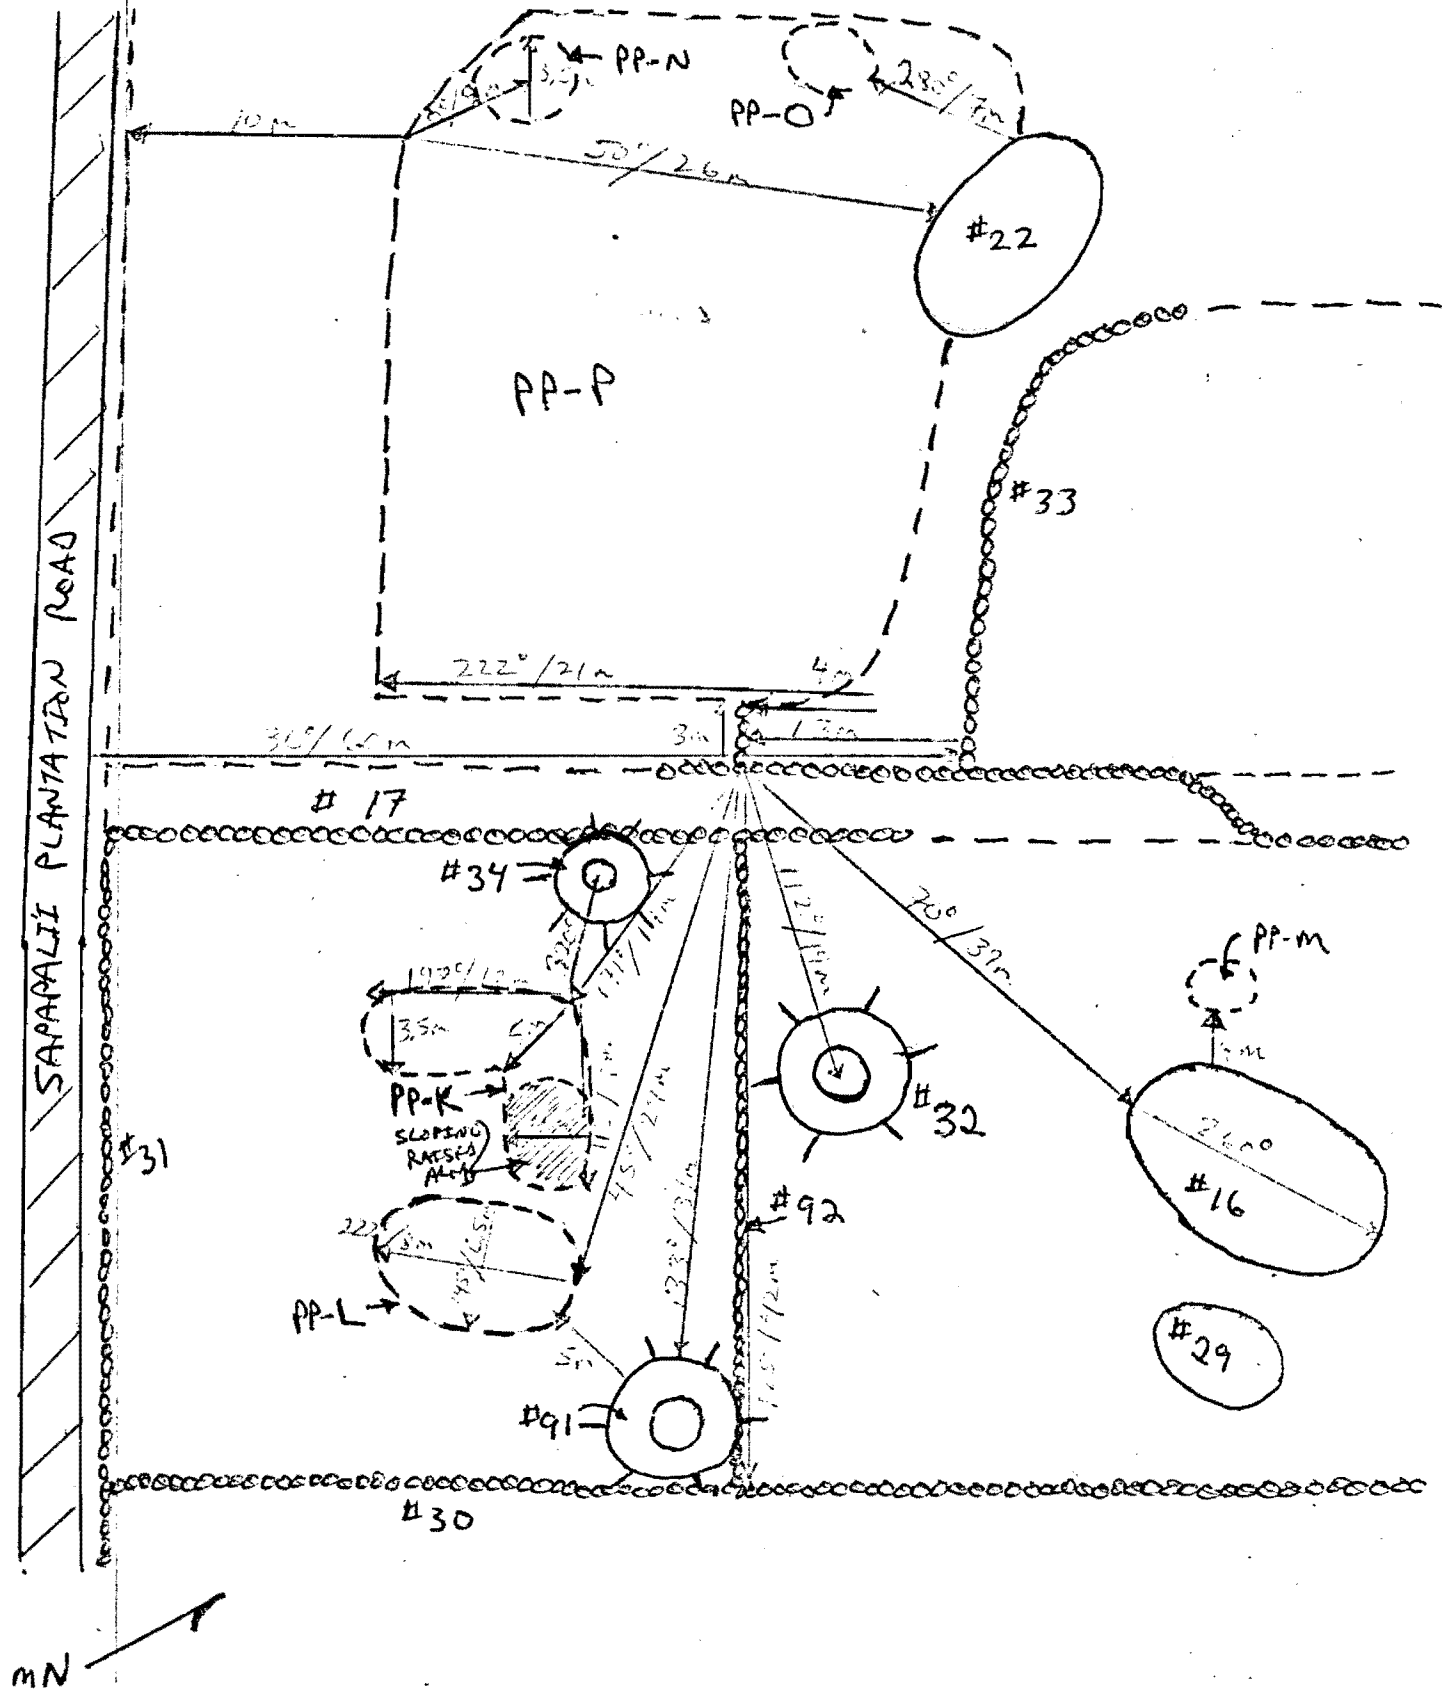
SKETCH MAP FOR SS-13-91, 92, 32, 34 AND PP-K TOP

- 1- 'UAM TI'
- 2- 8.5 m. DIAMETER / 30 cm
STONE CENTER 4 m DIA. / 80 cm. DEEP
- 3- RAISED EARTH SLOPS, STONE LINED DEPRESSION WHICH IS
CURBED w/ MEDIUM TO LARGE STONE (10-30cm) AND FILLED
w/ SIMILAR STONE. THE DEPRESSION HAS STEEP (60°) SLOPS
- 4- FAIR
- 5- SEE MAP ON BACK OF REPORT
- 6- FLAT
- 7- COCONUT TREE (720 m) ON N. EDGE
THICK, TALL BRUSH (2m) AND FERN
- 8- PP-L 5m. SOUTH AND OTHERS (SEE MAP)
- 9- SAPAPACII VILLAGE
- 10- SEEMS TO BE BUILT OVER WALL # 92 (∴ YOUNGER THAN
"92") BUT AGAINST WALL # 30
- 11- NONE
- 12- NONE

- 1- STONE WALL
- 2- 250 cm / 10 cm (42 m)
- 3- CONSTRUCTED MAINLY OF MEDIUM STONE w/ A FEW LARGE STONE (30-40 cm).
- 4- COVERED w/ FERN, MILK-A-MINUTE AND TALL BRUSH (>2 m) VERY ERODED.
- 'UMU TI' #91 BUILT OVER (?) WALL #92
- 'UMU TI' #32 BUILT AWAY FROM WALL #92

- 1- 'UMU TI'
- 2- 8 m. DIA / 30 cm.
STONE CENTER: 2.5 m DIA. / 20 cm. DEEP
- 3- RAISED EARTH MOUND w/ STONE FILLED CENTRAL AREA CIRCLED w/ MEDIUM TO LARGE STONE (20-40 cm) AND FILLED w/ THE SAME KIND OF STONE
- 4- GOOD (VERY LITTLE EROSION)
- 5- SEE MAP FOR SS-13-91, ETC.
- 6- FLAT
- 7- COCONUT TREE (>20 m) ON S. EDGE BETWEEN 'UMU TI' AND WALL #92
- 8- FERN AND MILK-A-MINUTE (1 m TALL) COVER SITE
- 8- SEE MAP (PP-1K CLOSET PLATFORM?)
- 9- SAPAALI'Z VILLAGE
- 10- ?
- 11- NONE
- 12- NONE

- 1- SMALL 'unm TI' (?)
- 2- 4.5 m DIA. / 10 cm.
STONE CENTER: 2 m DIA. / 20 cm. DEEP
- 3- LOW, RAISED EARTH SLOPS w/ A STONE FILLED CENTER
CURBED w/ MEDIUM TO LARGE STONE (20-40 cm) AND FILLED
w/ THE SAME KIND OF STONE. BUILT INTO RUBBLE OF EAST
WALL FOR WALLED ROADWAY #17
- 4- SLOPS VERY ERODED BUT STONE FILLED CENTER EVIDENT
- 5- AGAINST WALLED ROADWAY #17 (SEE MAP FOR SS-13-91, ETC.)
- 6- FLAT
- 7- COVERED w/ FERN (1/2-1 m TALL)
- 8- SEE MAP FOR SS-13-91, ETC.
- 9- SAPAPALI'I VILLAGE
- 10- YOUNGER THAN WALLED ROADWAY #17 WHICH IT IS
BUILT AGAINST AND ON. (ROADWAY #17 VERY LOW AND
ERODED AT CONTACT w/ 'unm TI' #34 AND FOR 80 m
ALONG ITS EAST WALL).
- 11- SEE 10 ABOVE
- 12- NONE

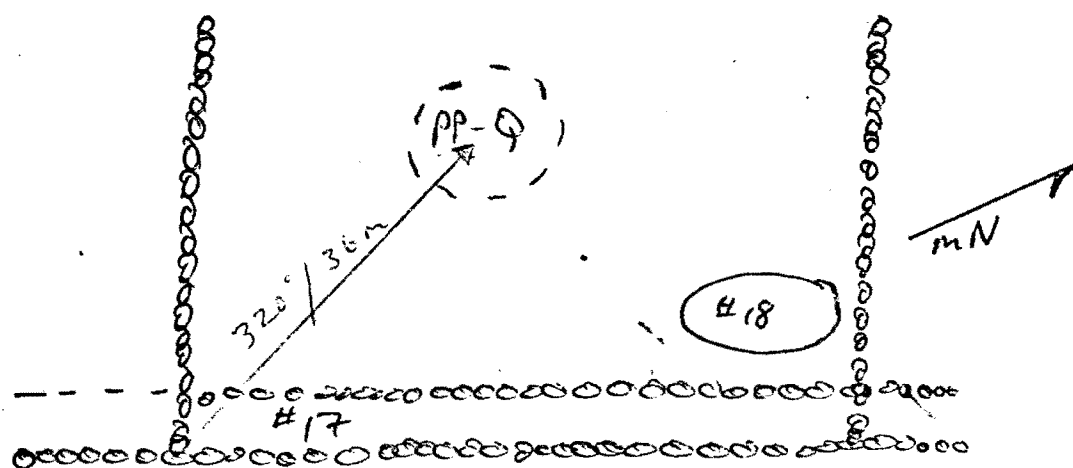
- 1- VERY LOW, CIRCULAR (?) STONY AREA
- 2- 10m(?) DIA. / <10cm (?)
- 3- CONSTRUCTED OF SMALL TO MEDIUM STONE w/ SOME LARGE STONE (30-40cm) IN SAME AREA
- 4- SURFACE EXTREMELY DISTURBED AND SCATTERED

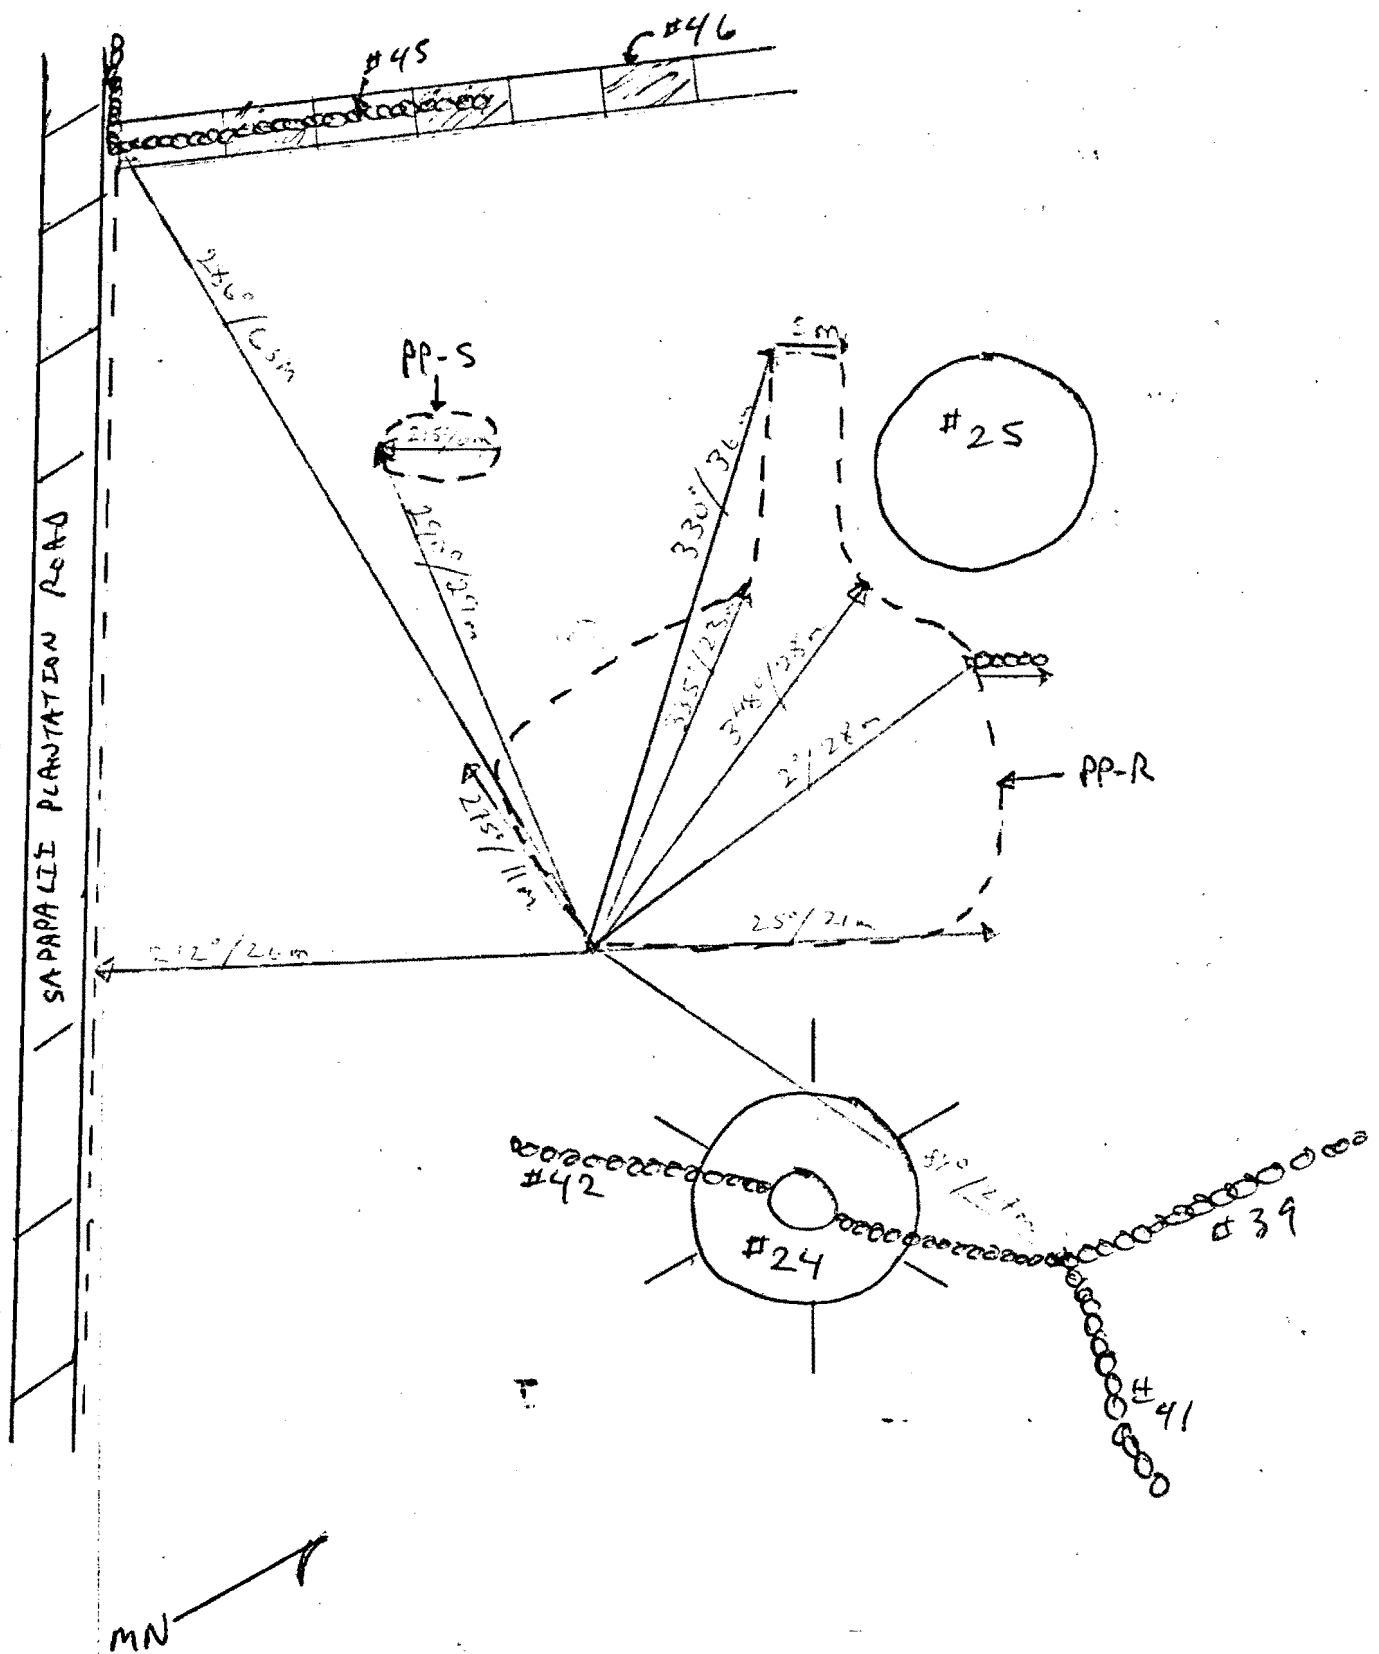
SKETCH MAP FOR PP-R AND S

- 1- Low, 'Q'-SHAPE STONY AREA
- 2- 27m (N25) X 36m (E20W) / 10 to 20cm
- 3- MAINLY CONSTRUCTED OF SMALL to MEDIUM STONE w/ A FEW LARGER STONE (30-40cm)
- 4- SURFACE VERY IRREGULAR BUT OUTLINE APPARENT
NW: ARM COMES w/IN 2m OF SS-13-25 BUT DOESN'T SEEM TO CONNECT.

- 1- OBLONG, MEDIUM HEIGHT.
- 2- 3.5m X 6m (215°) / 20cm
- 3- CONSTRUCTED OF SMALL to MEDIUM STONE w/ A FEW LARGER STONE (30cm)
- 4- SURFACE SLOPING FROM CENTER (30°)
SAME VEGETATION AS PP-R BUT NO COCONUT TREES ON SITE.
(SEE MAP ON BACK)

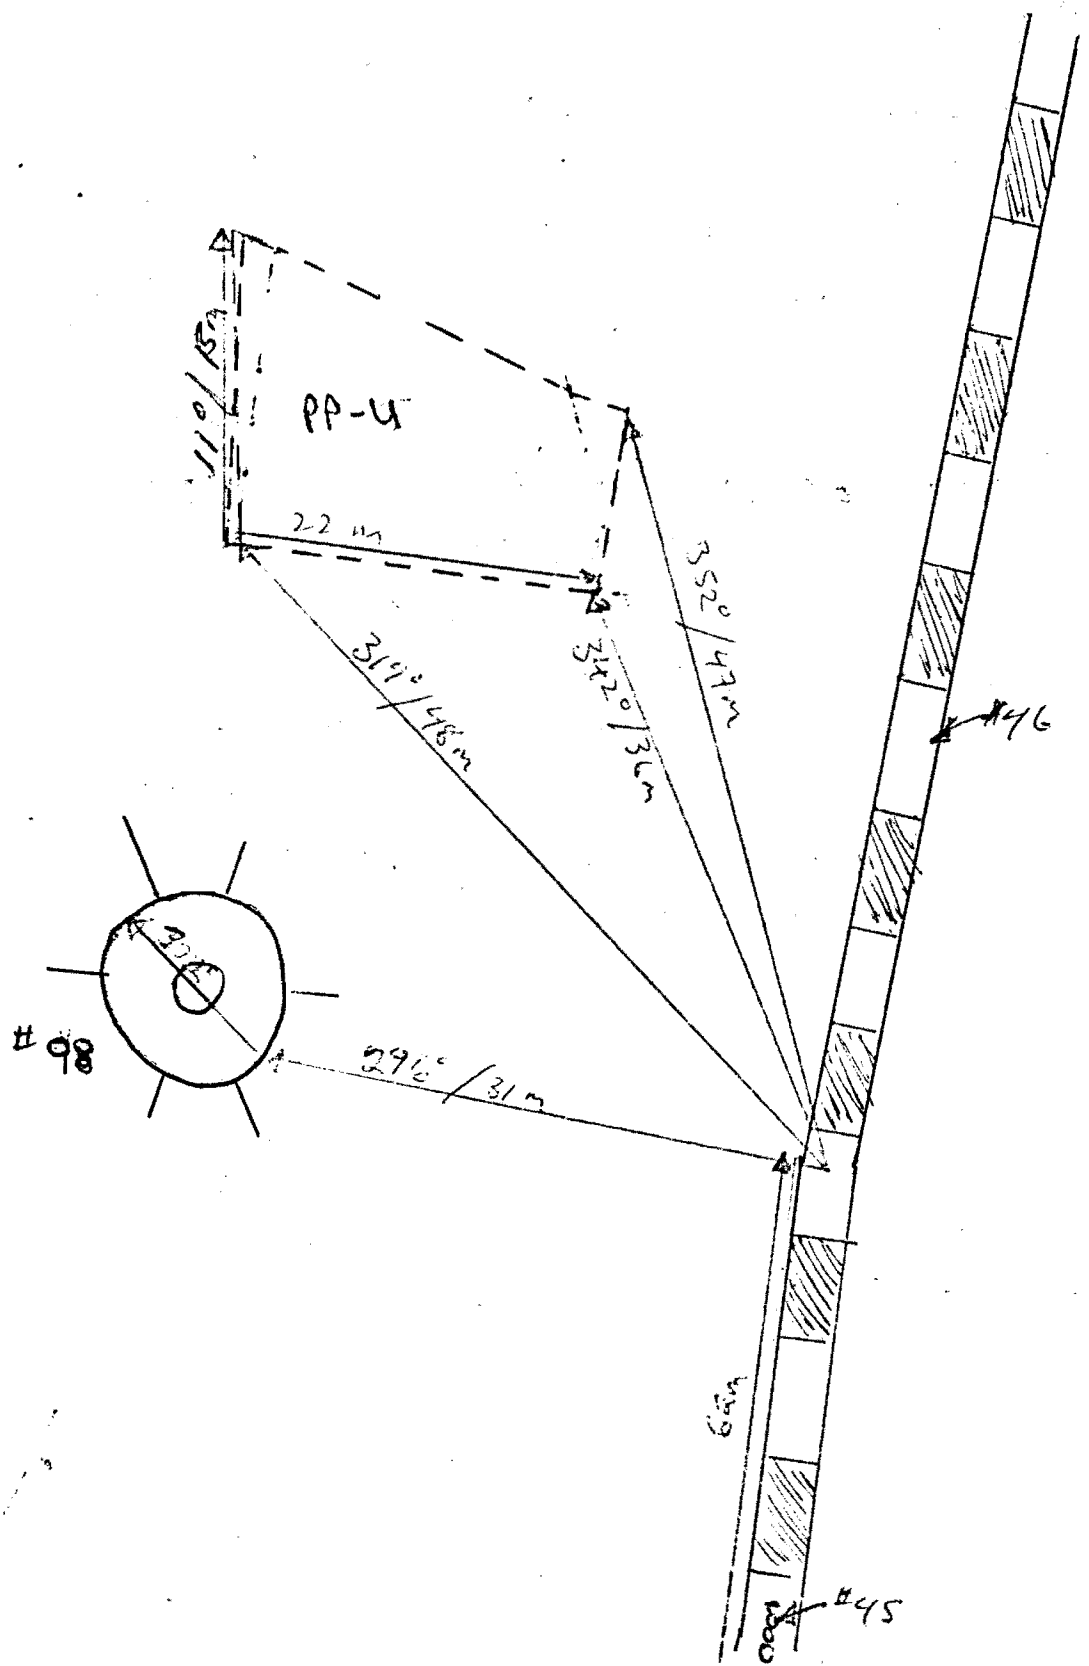
SKETCH MAP FOR SS-13-98 AND PP-U

- 1- 'Umm TI'
- 2- 8.5 m. DIAMETER / 40 cm
STONE CENTER: 3.5 cm DIA / 20 cm
- 3- RAISED EARTH SIDS, STONE LINGS DEPRESSION CURBED w/
MEDIUM TO LARGE STONE (20-30 cm) AND FILLED w/ MEDIUM
TO LARGE STONE (10-30 cm)
- 4- GOOD BUT STONE FILLED CENTER IS COVERED w/ 2 to 4 cm.
OF SOIL OBSCURING THE INTERIOR AND CURBING
- 5- SEE MAP ON BACK OF REPORT
- 6- RELATIVELY FLAT BUT CONTAINING SEVERAL LOW RISES AND
DZAS (20-40 cm) TO SW AND WEST.
- 7- COCONUT TREE (~15m) ON WEST SIDE, SMALL TREES (3-4m) COVERING
EAST ½ w/ FERN AND MILK-A-MINUTE ON WEST ½
- 8- PP-U TO NORTH (SEE MAP ON BACK)
- 9- SAPAPALI VILLAGE
- 10- ?
- 11- NONG
- 12- NONG

- 1- LOW, OVAL
- 2- 15m (110°) X 22m (295°) / 10cm
- 3- CONSTRUCTED OF SMALL TO MEDIUM STONE W/ LARGE STONE (20-30cm) ALONG EDGE
- 4- SURFACE VERY LARGELY: COCONUT TREES ON AND AROUND (>10m TALL), BRUSH & SMALL TREES (~50m) ON WEST 1/2 OF SITE. FEW AND MILD A-MINUTES (<1/2m) ON EAST 1/2

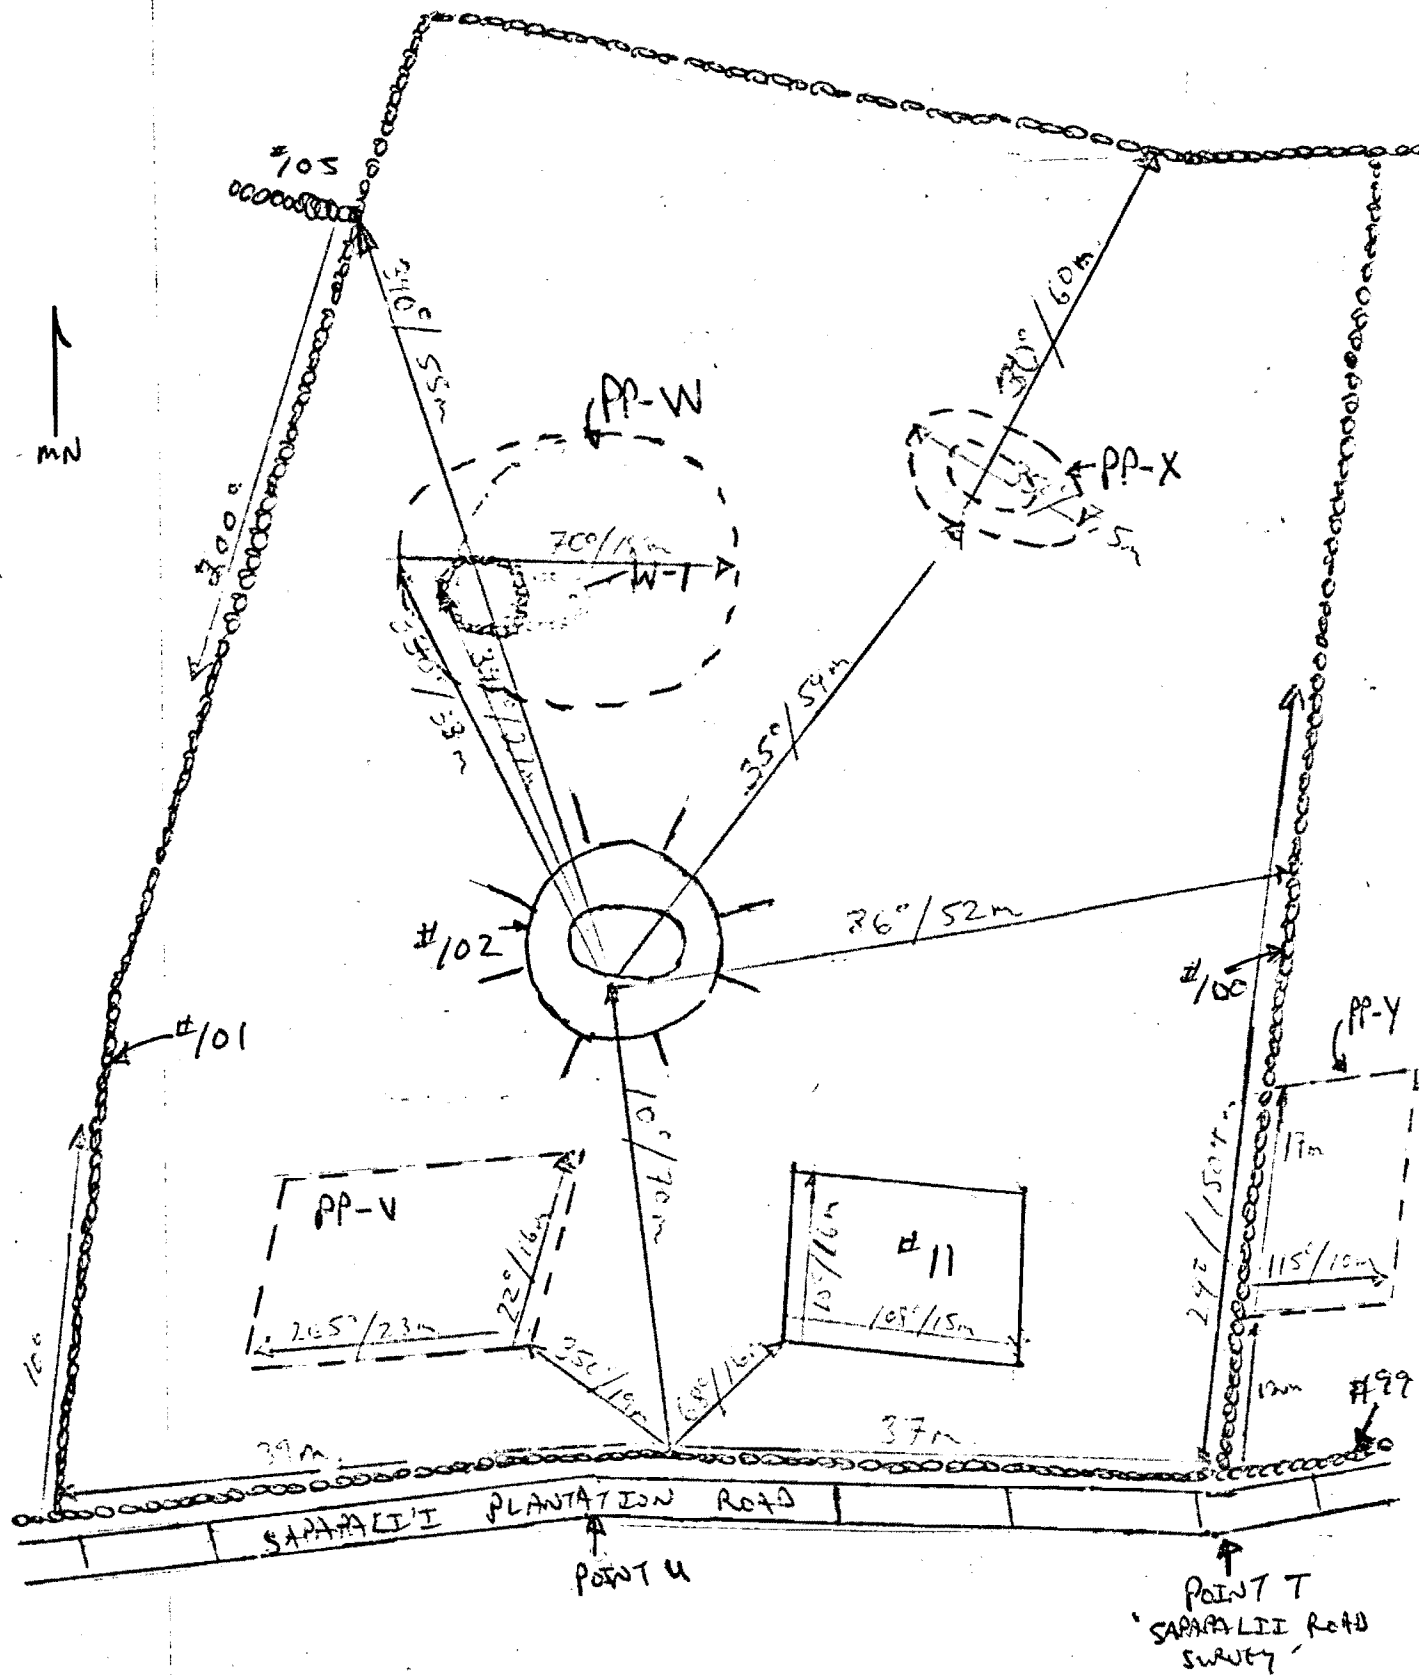
SKETCH MAP FOR SS-13-99 TO 102
AND PP-V TO Y

- 1- STONE WALL
- 2- 50cm / 40cm (~282m.)
- 3- CONSTRUCTED OF MEDIUM TO LARGE STONE (20-40cm)
- 4- VERY DISTURBED, PROBABLY LIKE WALL #100 AT ONE TIME. OTHER MEDIUM TO LARGE STONES SCATTERED IN AREA OF WALL. MAY BE AN EXTENSION OF WALL #31 ALONG SHAPALI PLANTATION ROAD. (SEE MAP ON BACK)

- 1- STONE WALL
- 2- 25cm / 70cm (150+m)
- 3- CONSTRUCTED OF MEDIUM TO LARGE STONE (20-50cm). SINGLE STONE THICK
- 4- THERE DOES NOT APPEAR TO BE AN OLD WALL UNDERNEATH. PASSES OVER WEST EDGE OF PP-Y. COLLAPSED IN SOME PLACES & LOOKS LIKE WALL #99 (SEE MAP ON BACK)

- 1- STONE WALL
- 2- 20cm / 80cm (150+m) 8
- 3- CONSTRUCTION OF MEDIUM TO LARGE STONE. ONLY A SINGLE STONE THICK.
- 4- SMALLER STONE DEBRIS IN GRAVEL AREA OF WALL BUT NO OBSERVABLE SHAPE

- 1- 'COPRA DRYER' (?) (Cumm TI '(??)')
- 2- 13.5m (20°) X 12.5m (110°) / 1.1m
CENTRAL PIT: 3.5m (20°) X 5.5m (110°) / .8m DEEP
- 3- RAISED EARTHEN ~~SIDE~~ SLOPING AT ~45° W/ AN
ELLIPTICAL, CENTRAL PIT. THE PIT HAS VERTICAL
SIDES FACED W/ MEDIUM TO LARGE STONE (20-40cm)
NO STONE OBSERVED IN PIT EXCEPT THOSE COMING FROM
THE CALASSES INTERNAL FACING. CHARCOAL BITS (<1cm) MIXED
W/ SOIL OBSERVED IN BOTTOM OF PIT.

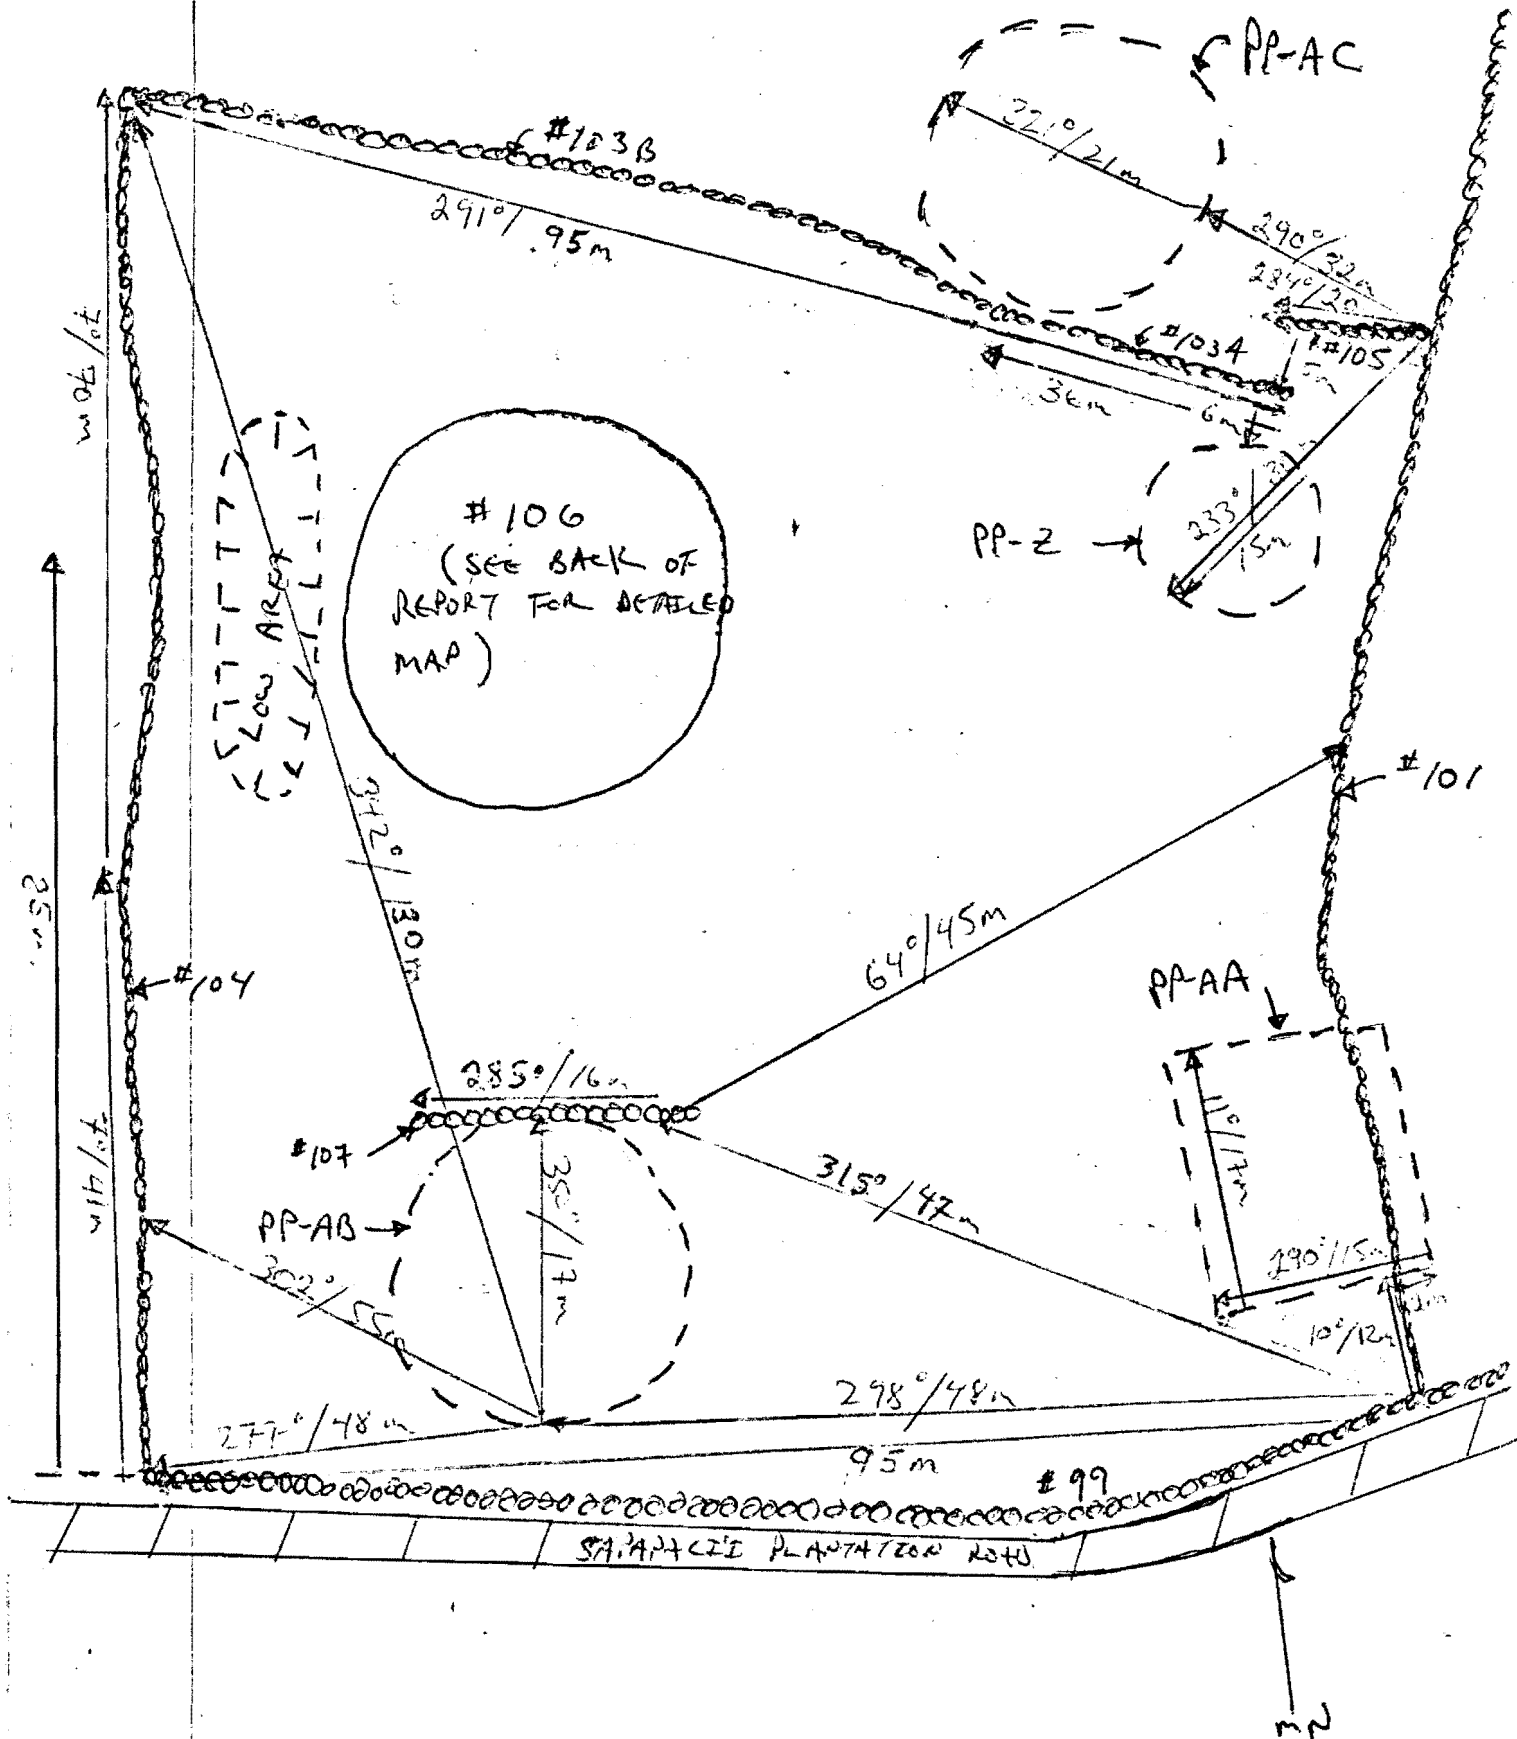
SKETCH MAP FOR SS-13-103 TO 106
AND PP-Z TO AC

→ 103A
- 3- 103A: CONSTRUCTED OF MEDIUM TO LARGE STONE (20-40cm), ONE STONE THICK. ERODES IN PLACES.
103B: CONSTRUCTED OF SMALL TO MEDIUM STONE, ERODES IN PLACES
- 4- WALL #105 TO N OF #103A MAY BE THE OLD WALL TO WHICH #103B CONNECTS AND 103A MAY BE A RECENT RECONSTRUCTION (USING MATERIAL FROM WHAT MAY HAVE BEEN AN EXTENSION TO THE WEST OF #105)

- 3- CONSTRUCTED OF MEDIUM TO LARGE STONE (10-40 cm)
- 4- ERODES IN PLACES (ESPECIALLY TOWARD ITS N. END)
SOME SCATTERED EVIDENCE OF DEGREES IN THE AREA OF WALL
#104 BUT VERY SCATTERED AND OF NO OBSERVABLE SHAPE.

- 1- STONE WALL
- 2- 120 cm / 20 cm (20 m)
- 3- CONSTRUCTED MAINLY OF SMALL TO MEDIUM w/ A FEW LARGE STONE (30-40 cm)
- 4- VERY ERODED, PROBABLY A 'BLOWN SITE' FOR MATERIAL FOR WALL #103A.

- 1- LARGE CIRCULAR STONE PLATFORM OF MEDIUM HEIGHT
- 2- 35m. DIA. \times 20 cm (IN 2 STEPS OF 10 cm)
- 3- CONSTRUCTED OF SMALL TO MEDIUM STONE (MAINLY MEDIUM) w/ A FEW SCATTERED LARGER MEDIUM (20-25 cm). CURBED ON OUTSIDE BY ROUNDED (RIVER WORN), MEDIUM TO LARGE STONE (20-30 cm) 10 cm. HIGH. AN INTERNAL CURBING 120 cm FROM EXTERNAL CURBING IS MADE OF FLAT (LONG/THIN) STONES (30 cm \times 15 cm) PLACED VERTICALLY ^{PRODUCING ANOTHER} INTO THE SURFACE OF THE PLATFORM AND 10 cm. RISE. IN THE PLATFORM, THE AREA BETWEEN THE EXTERNAL & INTERNAL CURBING (WHICH IS NOW COVERED w/ A 2-3 cm DEPOSIT OF SOIL) IS FILLED w/ SMALL STONE. 1 LARGE STONE (40 cm \times 50 cm) IS LOCATED ALONG THE INTERNAL CURBING LINE AND 'BURRERS' \sim 10 cm IN SIZE BUT RESTING ON STONE. ONLY ONE OF CURBING WAS OBSERVED ON THE SURVEY

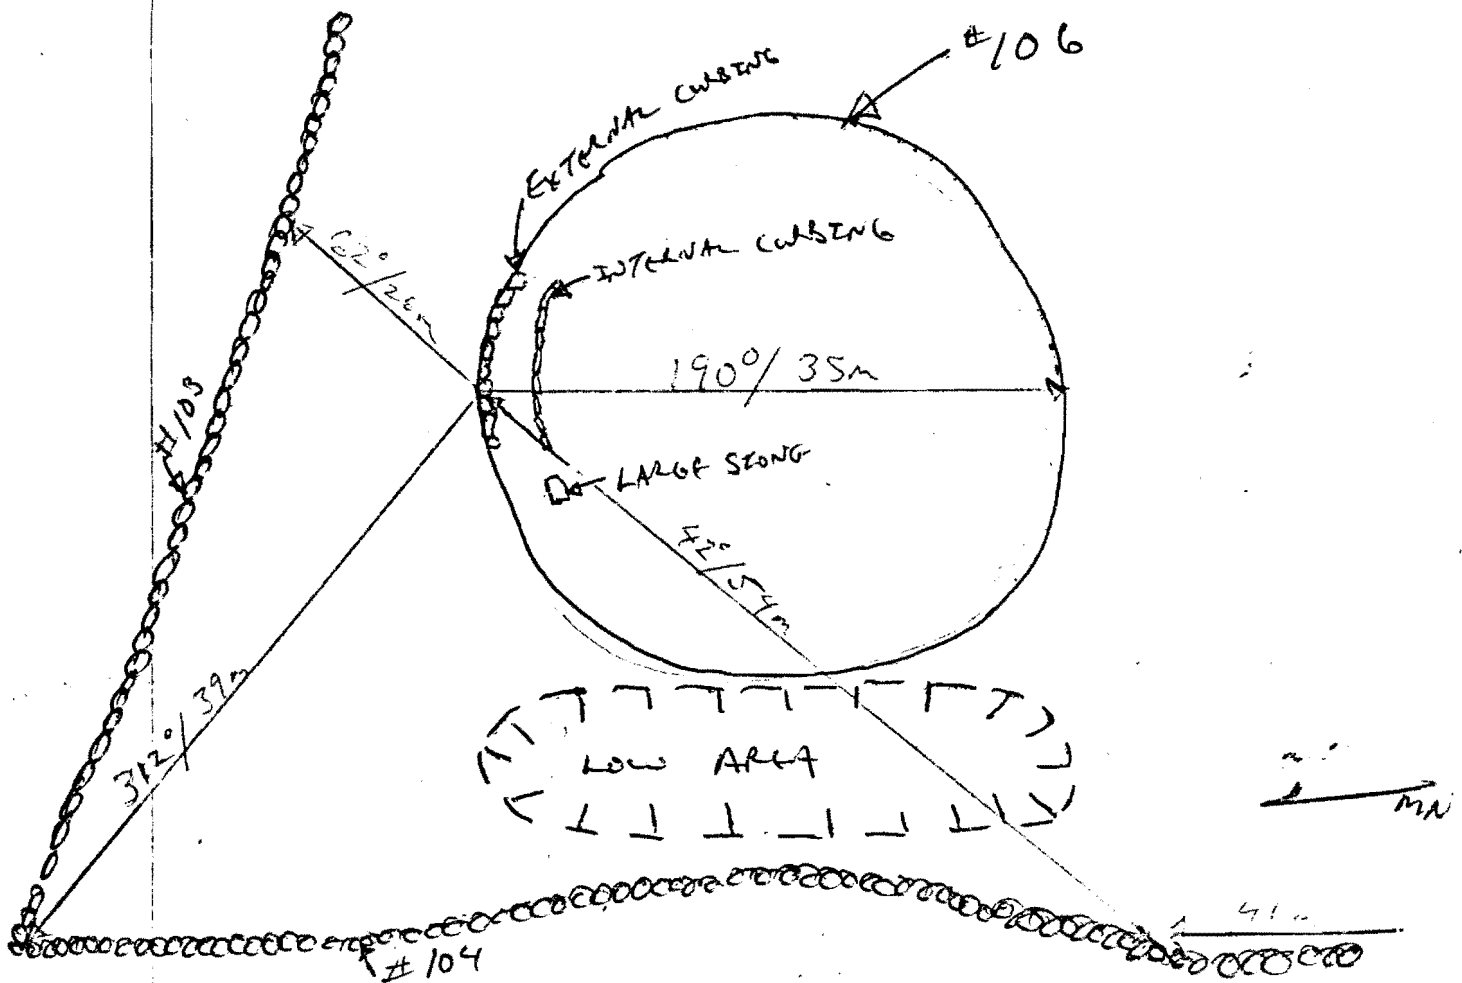
- 11- STRUCTURE SIMILAR TO MODERN 'FALL TELE' (GUYOT OR METEOR HOUSE)
 A LOW AREA (8m X 35m) IS TANGENT TO THE WEST EDGE OF PLATFORM #106. IT IS 40 TO 60 CM BELOW THE PLATFORM SURFACE AND SURROUNDING TERRAIN. SIDES AND ENDS ARE SCALING. SCATTERED STONE TO MODERN SIZE ARE EVIDENT THROUGHOUT THE AREA. COVERED w/ BRUSH (1-1½ m TALL). NO OBSERVES FACING OR WINDS W/IN THE LOW AREA BUT IT DOESN'T SEEM TO FIT INTO LOCAL GEOMORPHIC CONTEXT. (MAN MADE??)
- 12- NONE

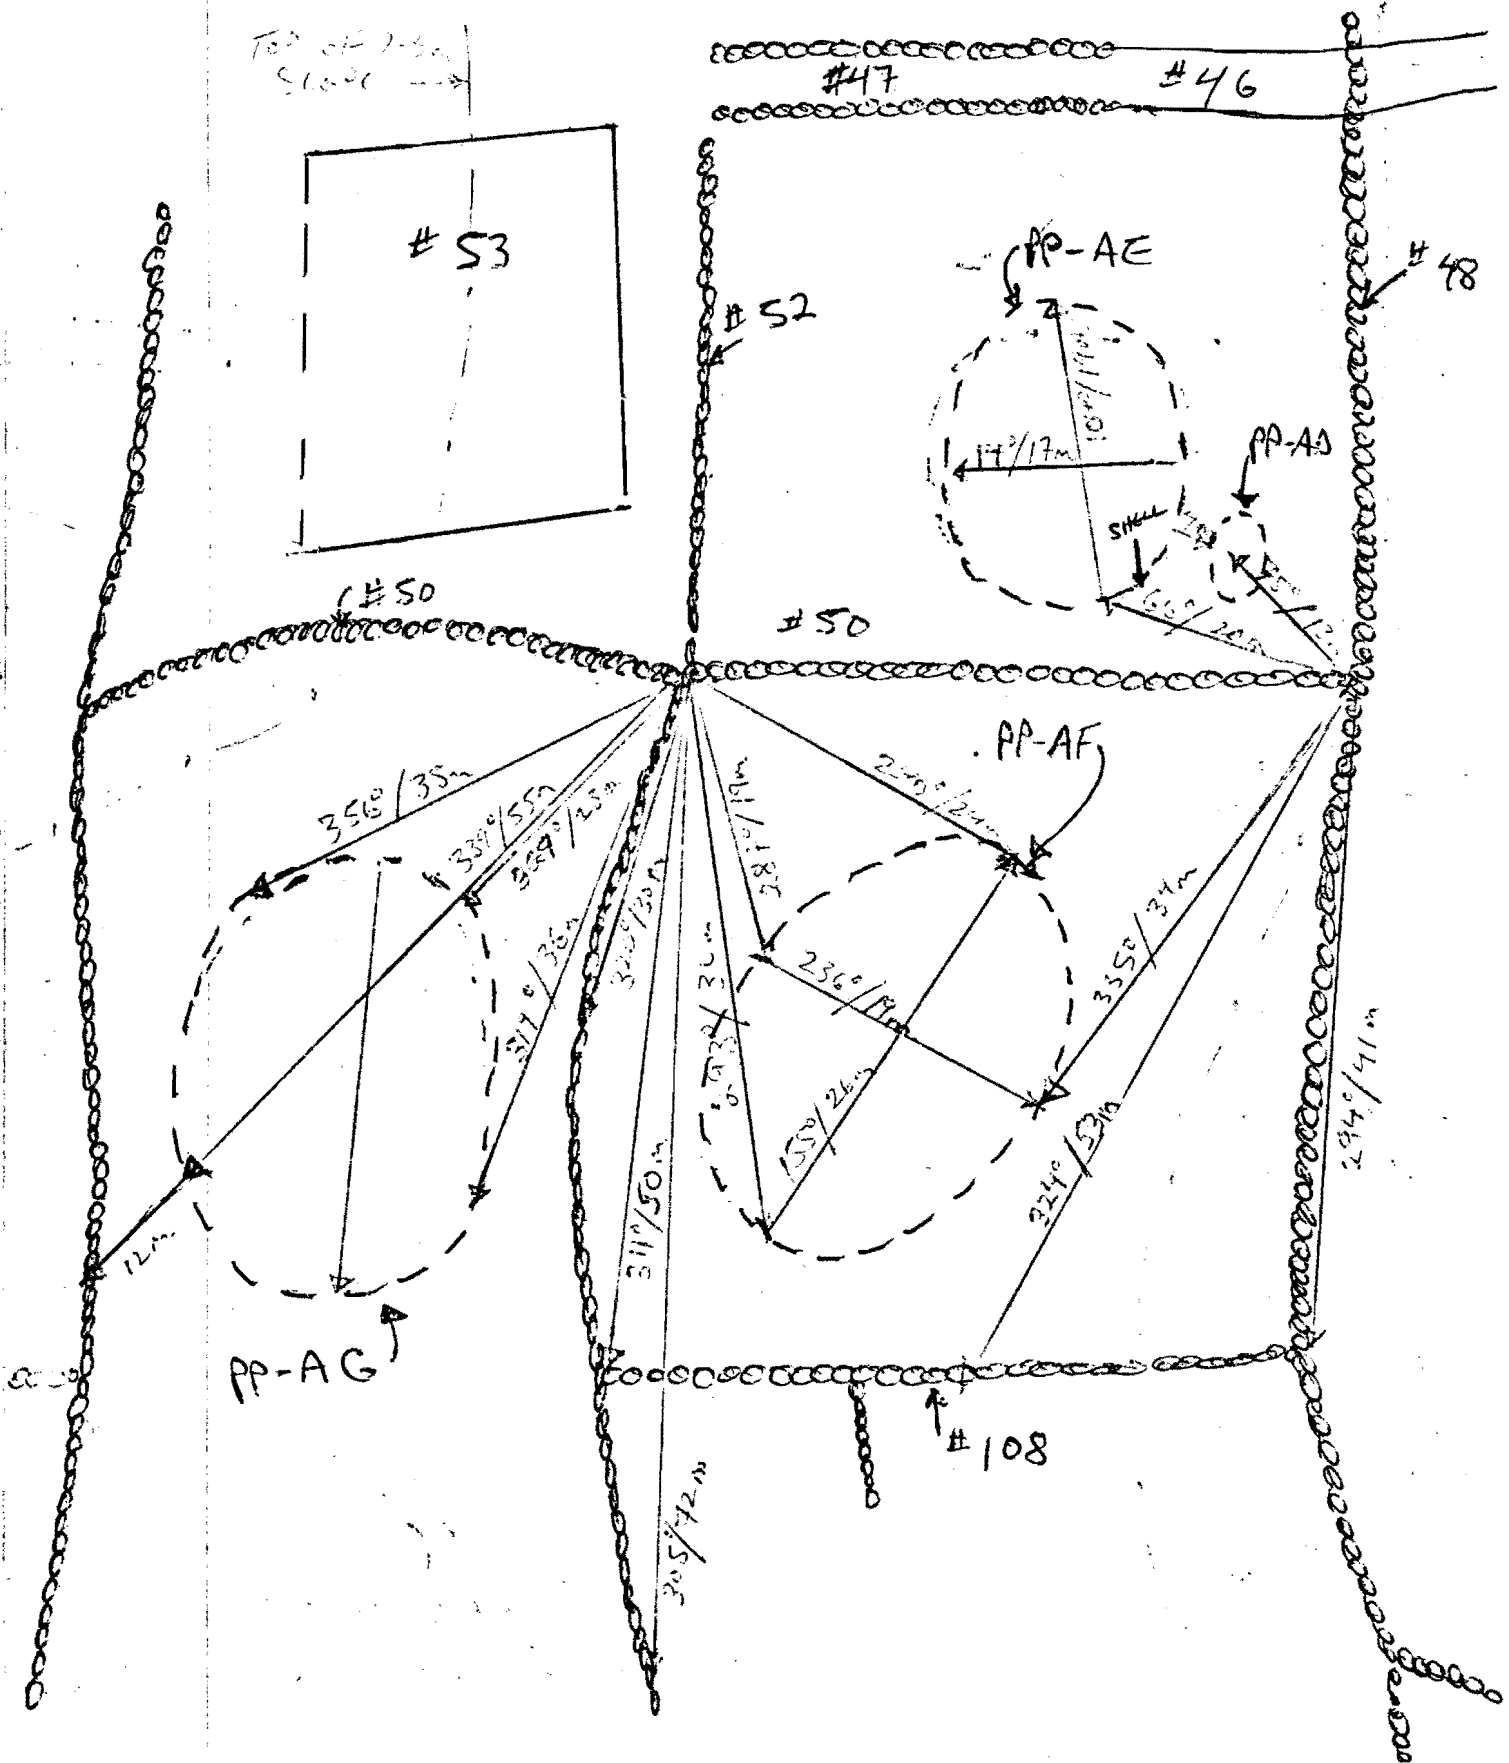
SKETCH MAP FOR SS-13-108 AND
PP-AD TO AG

- 3- CONSTRUCTED OF MEDIUM TO LARGE STONE
- 4- DENSELY COVERED w/ Fern AND WOODS (1m tall) w/
A LARGE BROADLEAF TREE (~1m DIA) GROWING ON WALL
LESS MRS IN WALL ON SOUTHERN $\frac{1}{3}$
(SEE MAP ON BACK)

- 1- OBLONG(?), VERY LOW AND FLAT.
- 2- 2m x 4m / <10cm
- 3- ^{CONSISTS OF} A DARK BROWN TO BLACK SOIL (UNLIKE THE LIGHT
BROWN TO BROWN SOIL OF THE SURROUNDING AREA)
w/ MEDIUM SIZED STONE IMBEDDED IN THE DARK SOIL.
THE MEDIUM STONES FORM A LOOSLY LINKED ELLIPTICAL (?)
SHAPE. SMALL STONE ARE SCATTERED IN THE SAME AREA
BUT DON'T APPEAR TO BE PART OF THE STRUCTURE(?).

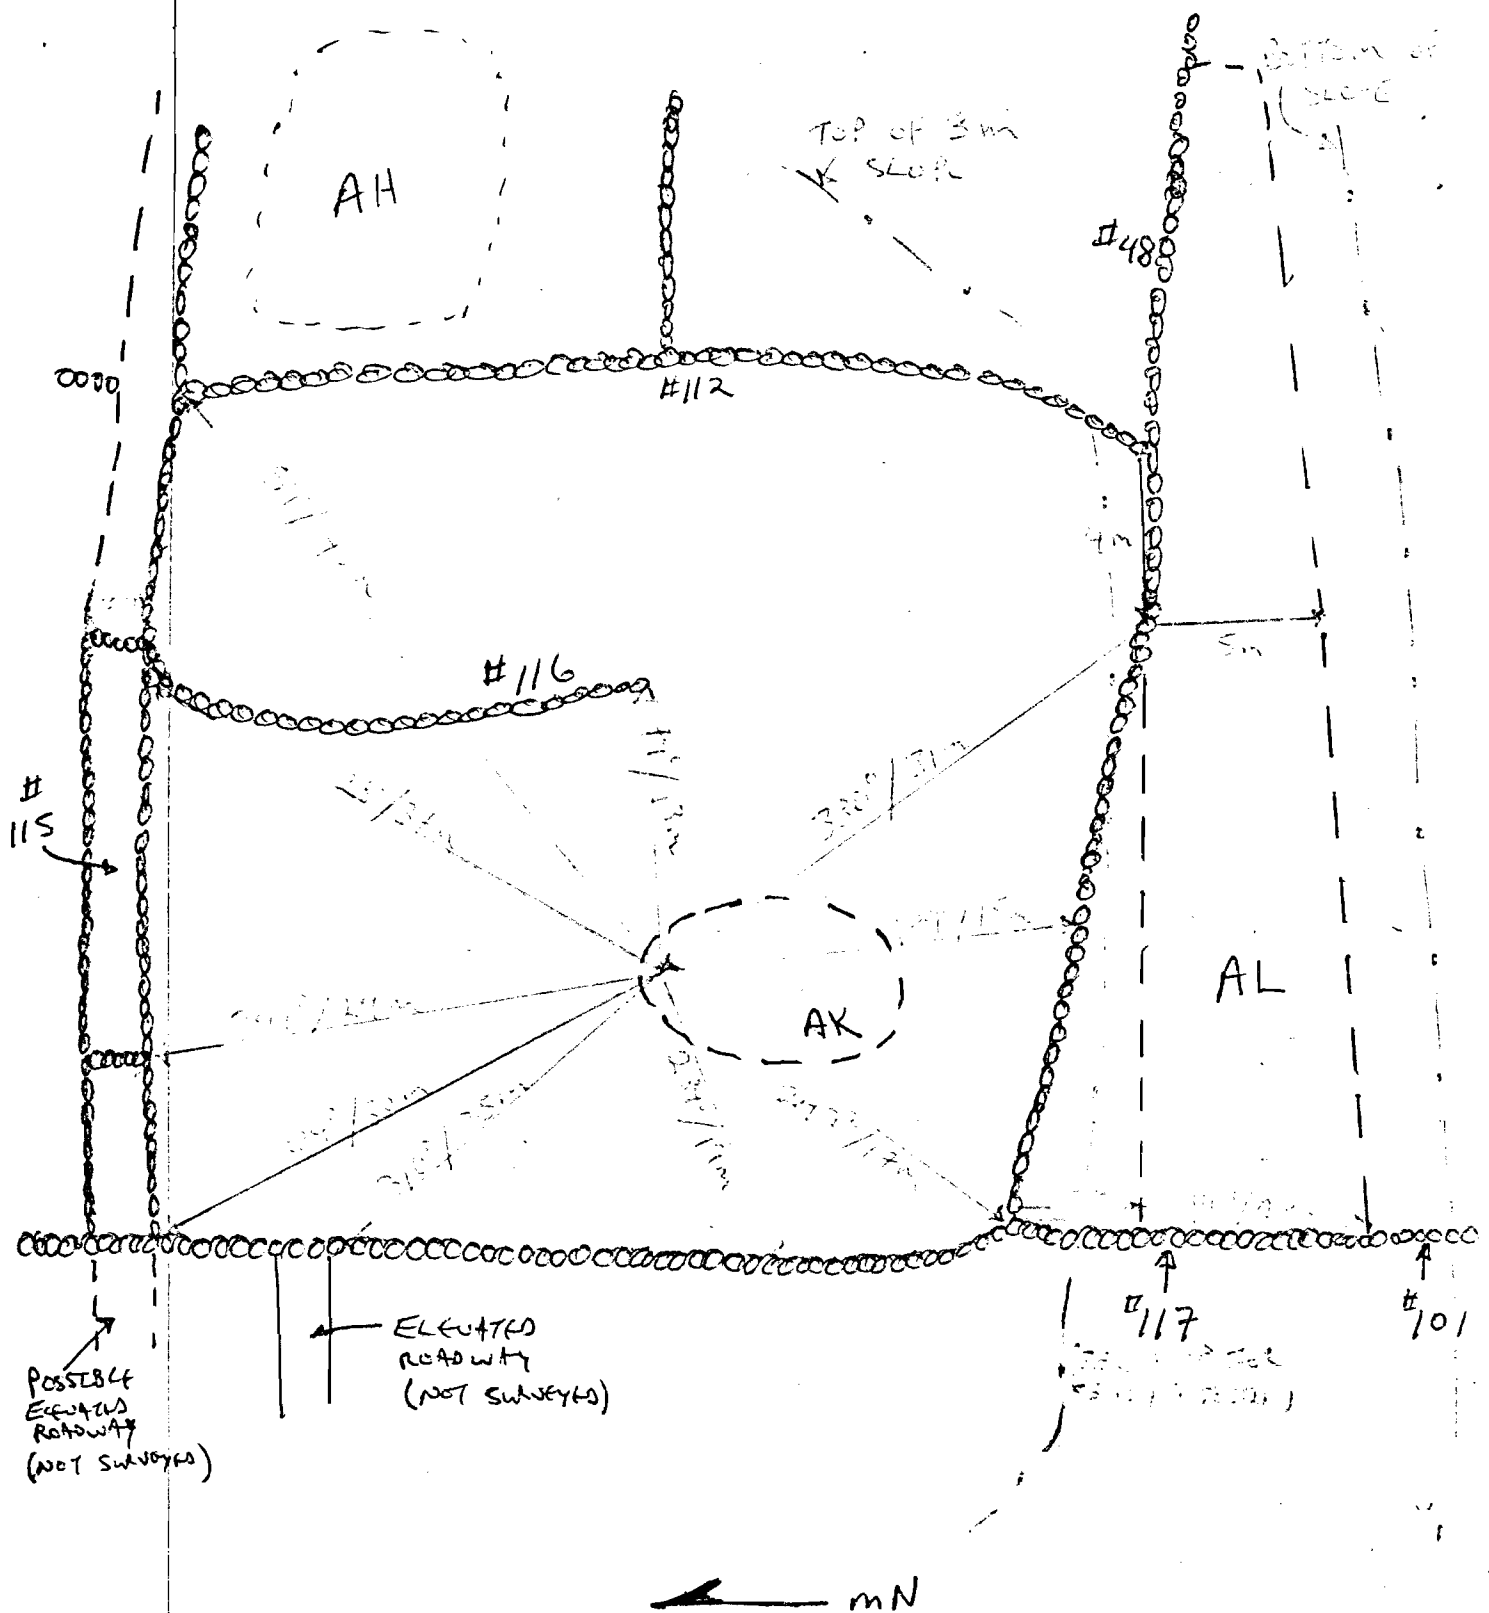
SKETCH MAP FOR SS-13-116
AND PP-AK to AL

- 1- OBLONG, MEDIUM HEIGHT
- 2- 6m X 10m (174°) / 40cm
- 3- CONSTRUCTED OF MEDIUM TO LARGE STONE W/ LARGE STONE AROUND EDGES (BUT NO FACING). SLOPING STOPS (30°)
- 4- COVERED W/ FERN AND MIM-A-MINUTE ($\frac{1}{2}$ m) UNDER COCONUT PLANTATION. VERY BADLY DISTURBED

- 1- ROCK COVER SLOPE OF HILL
- 2- 10m (AV.) X 65m (100°) / ON 30-45° SLOPE 23m HIGH
- 3- CONSTRUCTED OF MEDIUM TO LARGE STONE W/ SOME SMALLER STONE.
