SAPAPALEI ROAD SURVEY
55-13-41 TO 163
BOOK II (P. K. TO BS)

SURVEY NOTES: SS-13-91 to 92, 98 to 163, AND PP-K to BS
SAPAPALII ROAD SURVEY / SAUAI, WESTERN SAMOA / BOOK II.
20.12.76 — 14.1.77

FAASAKELEAGA DISTRICT

SAVAI'I, WESTERN SAMOA

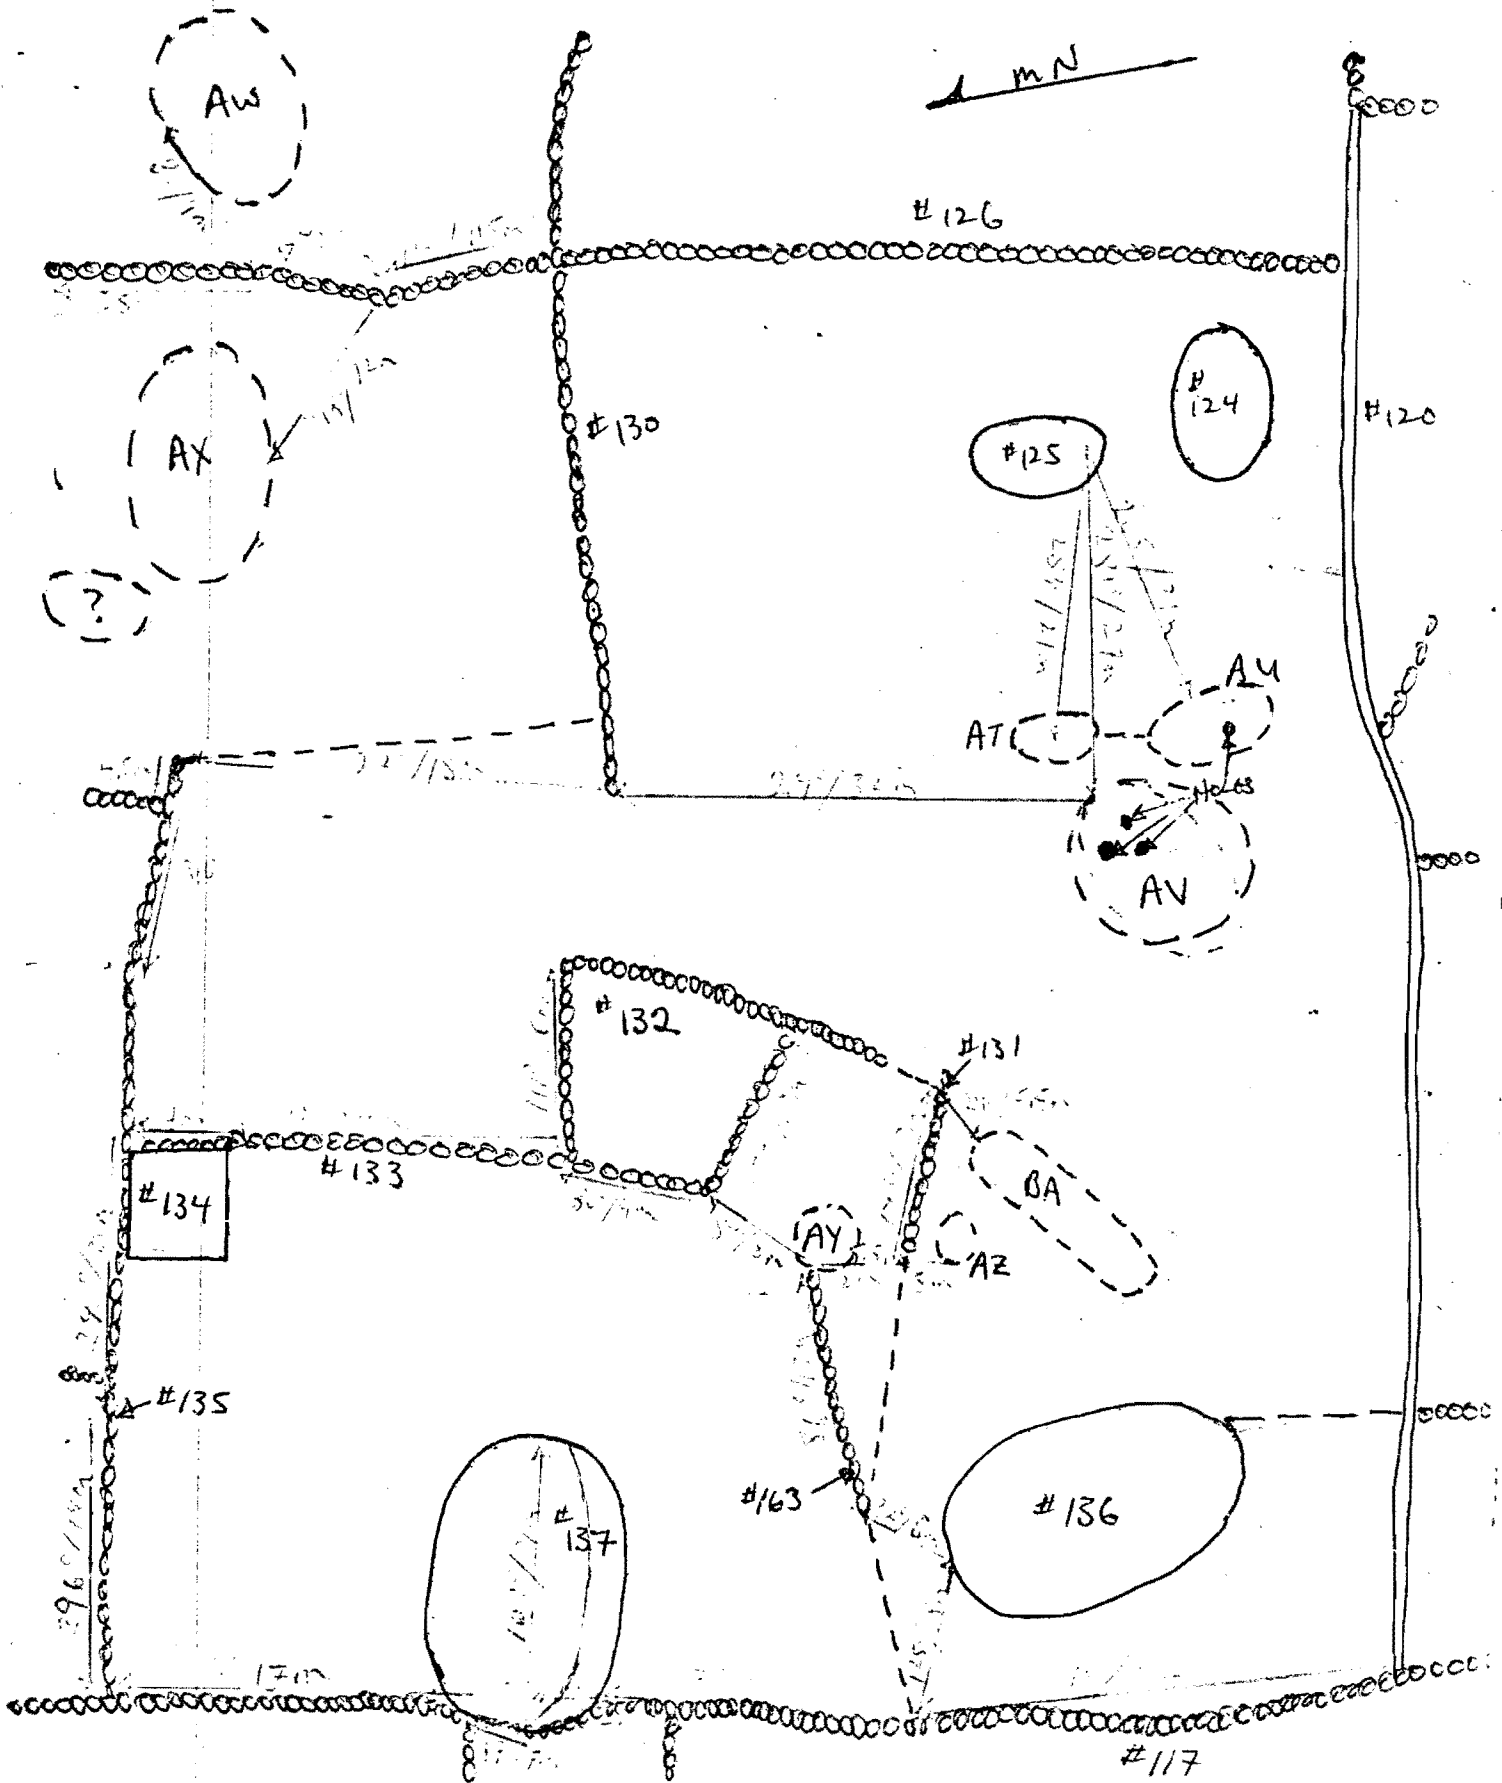
SKETCH MAP FOR SS-13-131 TO 137 AND 163
AND PP-AT TO BA

- 1- SMALL, HIGH, SQUARE, STONE PLATFORM w/ VERTICAL SIDES
- 2- 7m X 7m (296°) / 80cm
- 3- COMPOSED OF SMALL TO LARGE STONE w/ LARGE STONE MAKING UP VERTICAL FACING ON N, E & W SIDES. NORTH SIDE MADE OF (OR AGAINST WALL (WALKWAY?) #135, NO PAISING EVIDENT BUT SURFACE RELATIVELY SMOOTH.
- 4- GOOD, ONLY SMALL PORTIONS OF FACING DISTURBED
- 5- 206° X 296°
- 6- SLOPING TO SOUTH
- 7- SHORT FERN AND MILK-A-MINT (2m) COVER MOST OF PLATFORM w/ FOREST ON SOUTH EDGE
- 8- WALL (WALKWAY) #135 FORMS N. EDGE, WALL #133 BUILT OVER (OR FORMS) EAST EDGE
- 9- SAPAPALI'I VILLAGE
- 10- ?
- 11- NONE
- 12- NONE

- 1- STONE WALL (ELEVATED WALKWAY?)
 - 2- 400cm / 90cm (81m)
 - 3- CONSTRUCTED MAINLY OF MEDIUM TO LARGE STONE BUT SMALLER STONE ALSO OBSERVED
 - 4- SOME PARTS STILL TRAPAZOIDAL IN CROSS SECTION BUT MOST PORTIONS ELONGED.
- COVERED W/ DENSE FERN AND MICK-A-MINUTE (VIA) AS WELL AS FOREST.
- TERRAIN SLOPING TO SOUTH

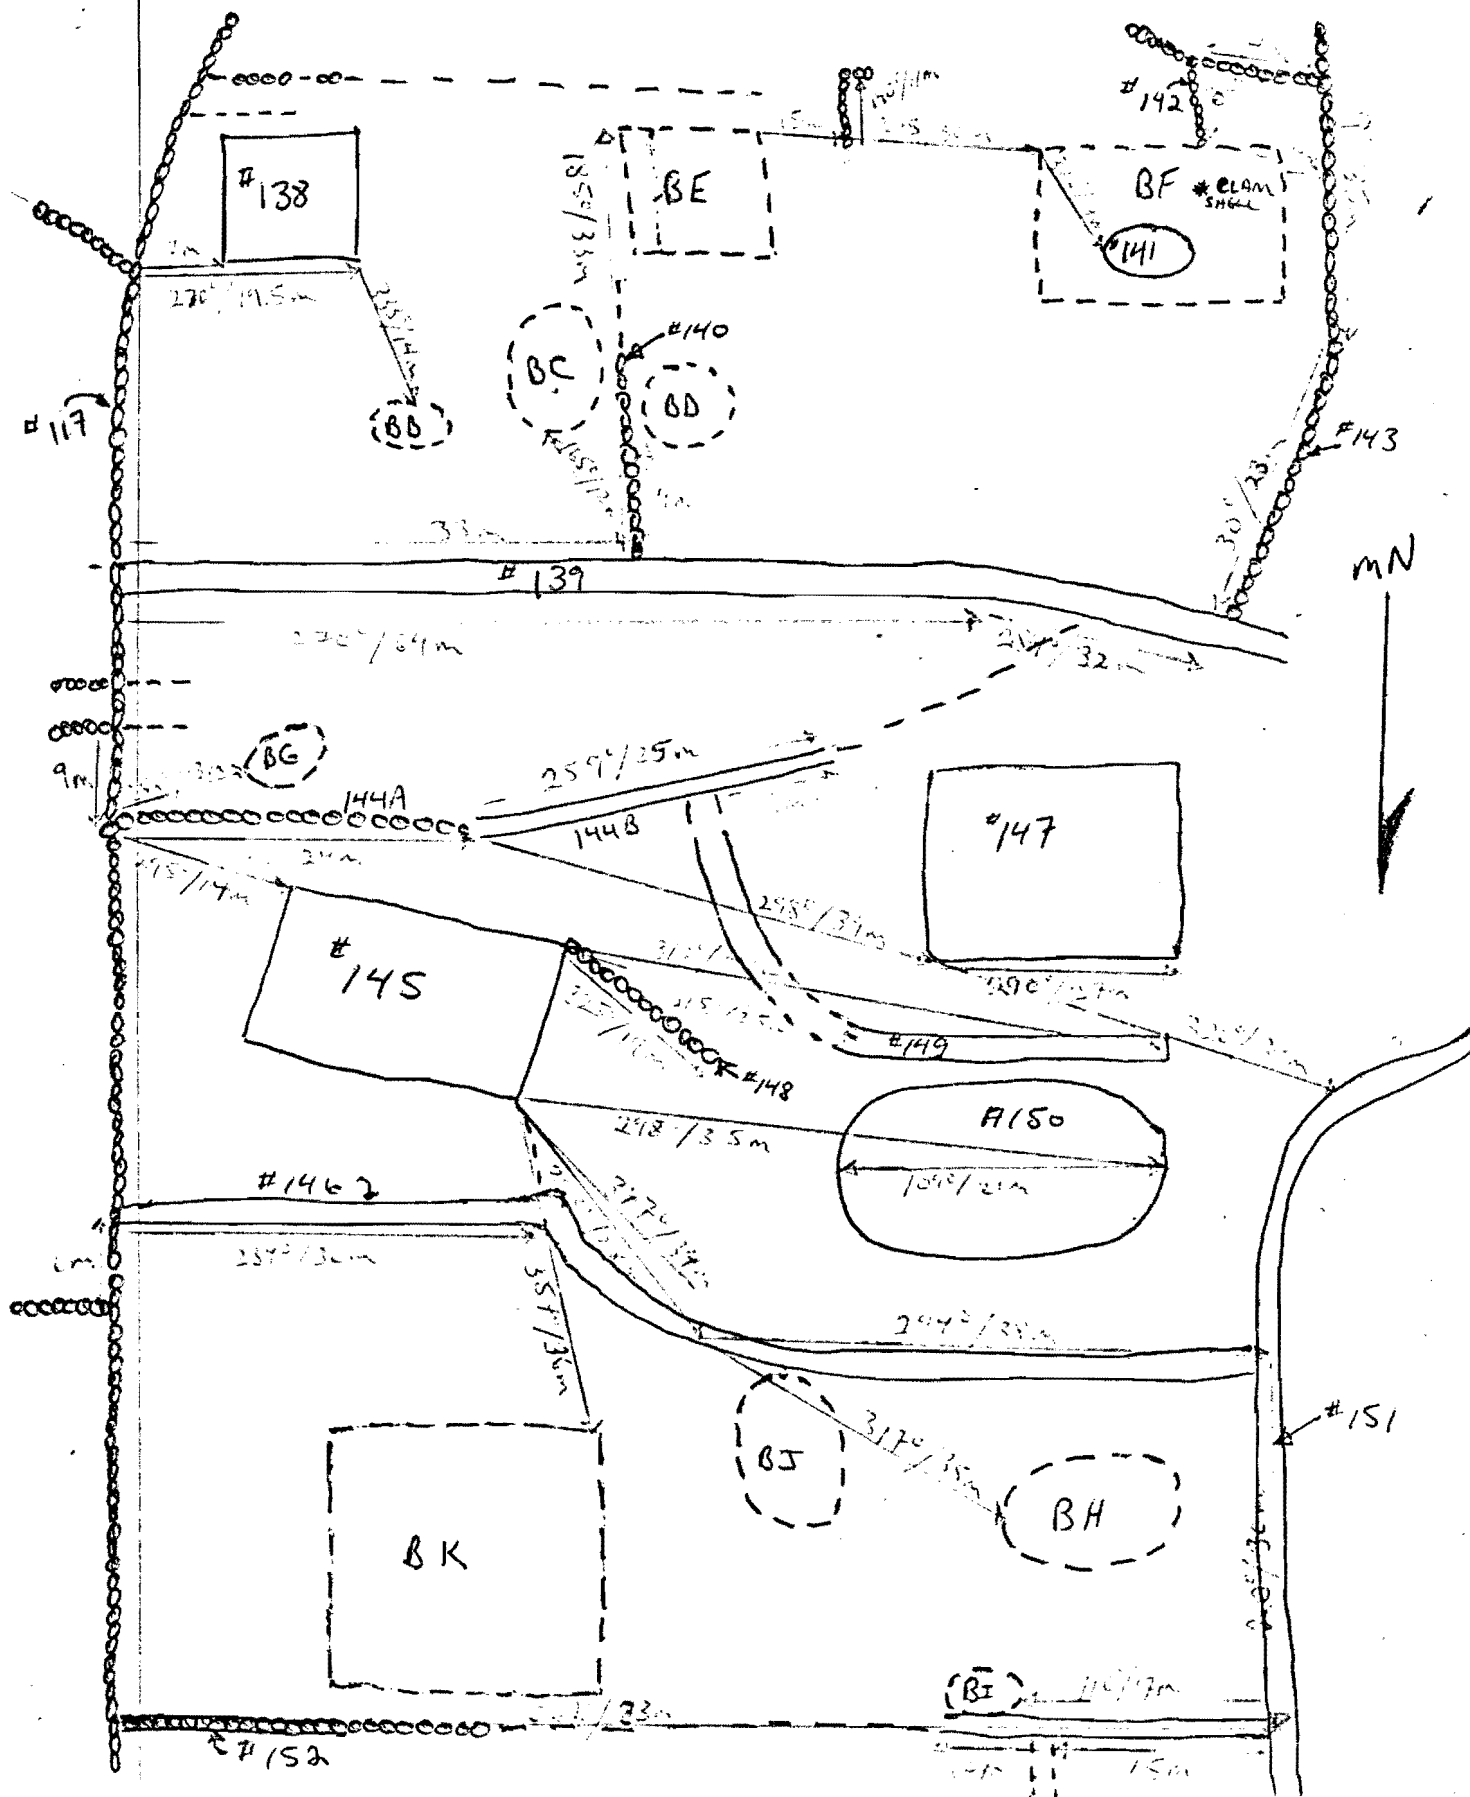
SKETCH MAP FOR SS-13-138 to 152
AND PP-BB TO BK

- 1- SQUARE, STONE PLATFORM OF MEDIUM HEIGHT AND SIZE
- 2- 12.5 (270°) X 13m / 40cm (ON A 2m. RISE)
- 3- 30 cm. FACING OF MEDIUM TO LARGE STONE (20-40cm)
ON S AND W EDGES, NORTH AND E EDGES
LOW (≤ 10 cm). INTERIOR CONSTRUCTED OF SMALL TO
MEDIUM STONE. PLATFORM BUILT ON 2m. RISE (HILL).
- 4- SW CORNER AND S EDGE SLIGHTLY ERODED
- 5- 270° X 180° / SEE MAP
- 6- SLOPING TO SOUTH
- 7- DENSELY COVERED W/ FERN AND WICK-A-MINUTE (1-1½m) w/
SOME BRUSH (2m+) ON SOUTH PART. COCONUT TREE ON
NW AND SW CORNERS (>20m TALL)
- 8- POSSIBLE WALLS 2m AND 8m SOUTH OF AND PARALLEL
TO THE SOUTH EDGE OF #138.
- 9- SAMAPALEI VILLAGE
- 10- ?
- 11- NONE
- 12- NONE

- 3- CONSTRUCTED OF MEDIUM TO LARGE STONE w/ LARGE STONE USED FOR VERTICAL FACING AND MEDIUM STONE USED FOR PAVING
- 4- BADLY ERODES IN PLACES PRODUCING SCALPING SCARS. DENSELY COVERED w/ FERN AND MILK-A-MINUTE ($\frac{1}{2}$ - $1\frac{1}{2}$ m). ROADWAY VERY DISTURBED (MISSING) IN PLACES (POSSIBLY CAUSED BY WATER EROSION).

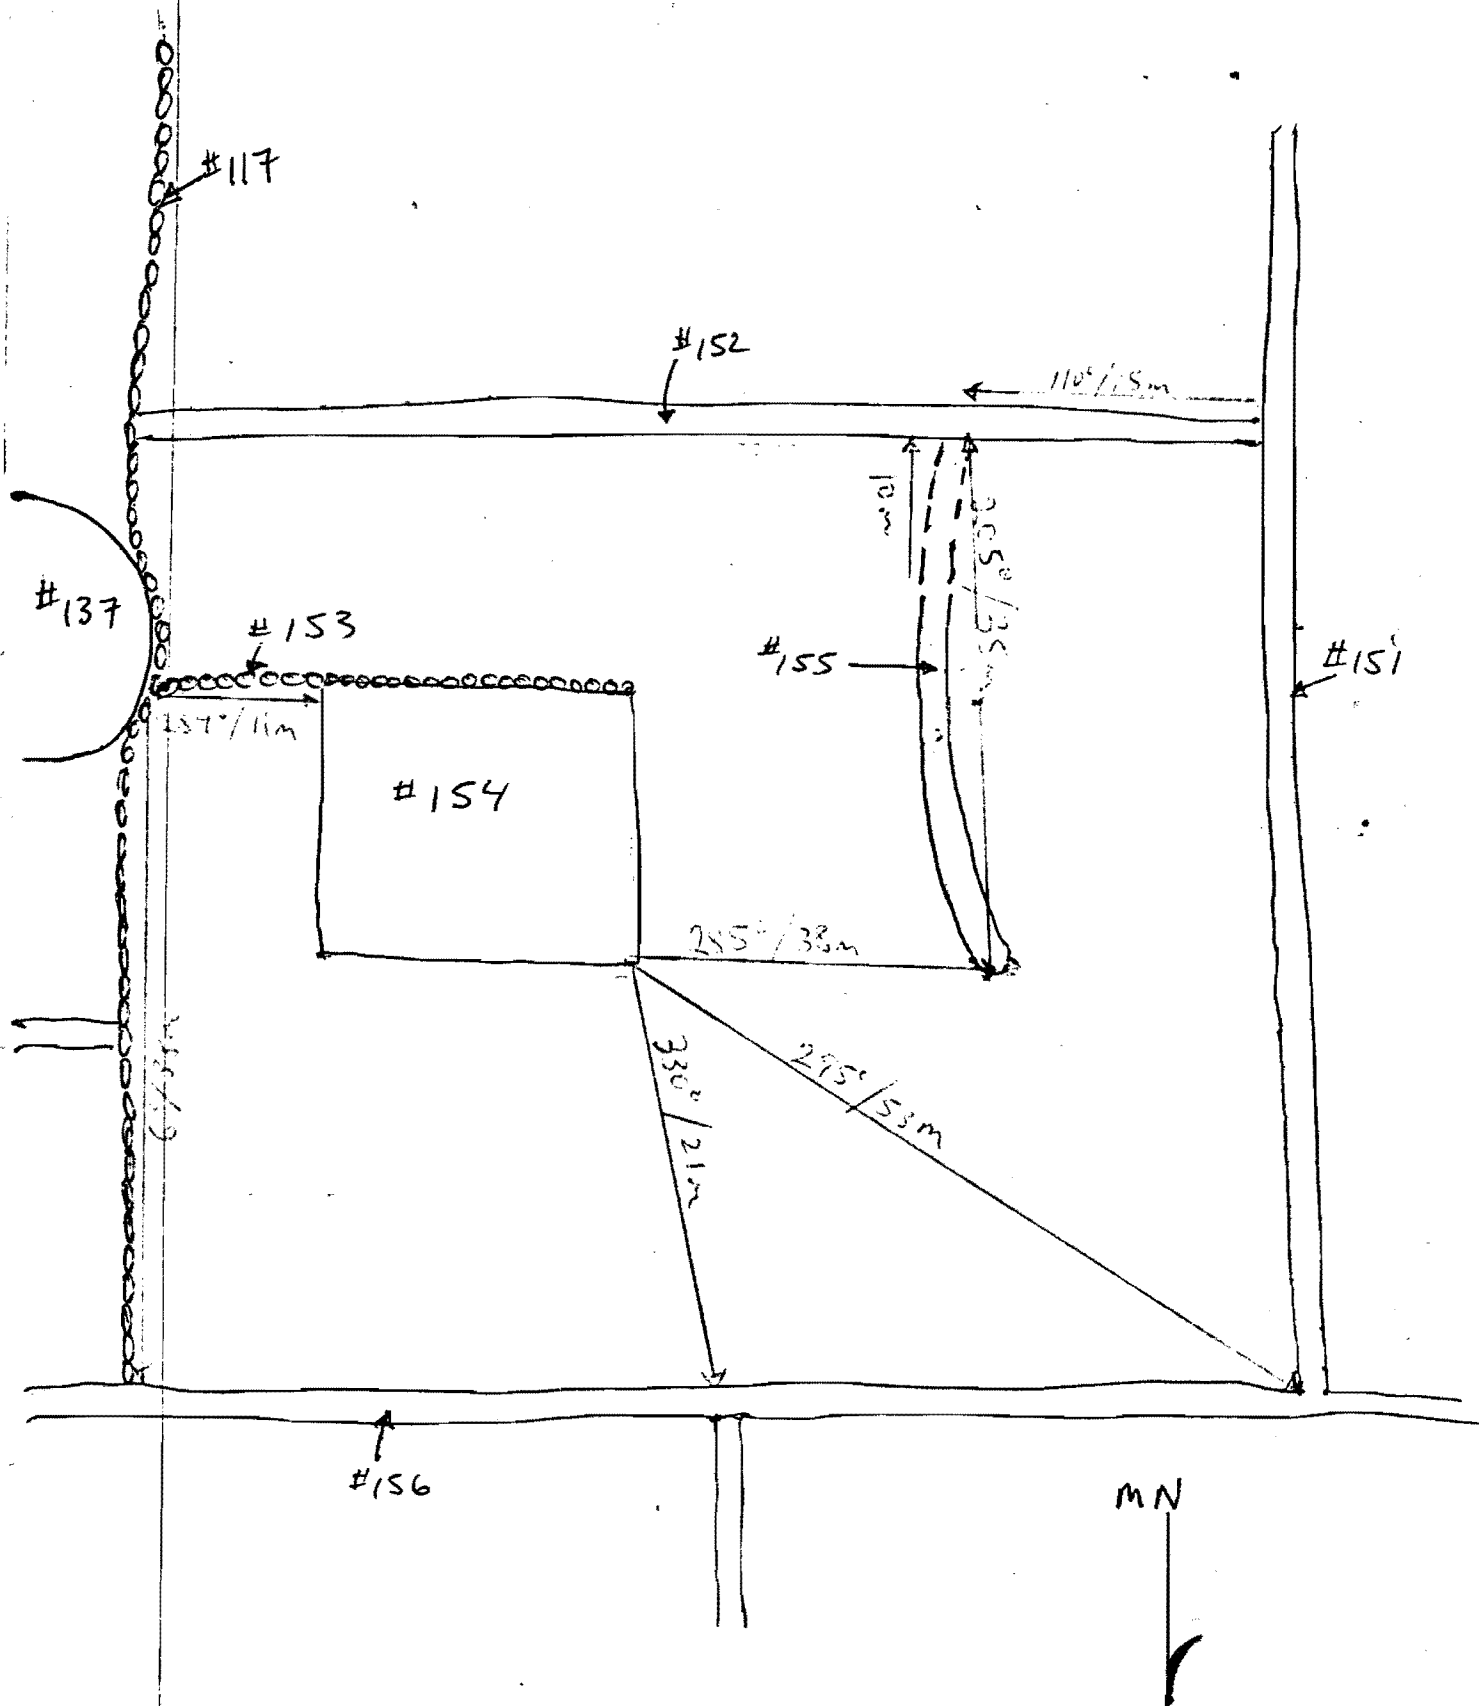
SKETCH MAP FOR SS-13-153 to 155

- 1- HIGH, RECTANGULAR STONE PLATFORM OF MEDIUM SIZE ^{W/ VERTICAL} SLOES
- 2- 12.5m (185°) X 22.5m (7°) / 80cm
- 3- CONSTRUCTED OF SMALL TO LARGE STONE W/ LARGE STONE USED FOR FACING ON S AND W EDGES. SMALL TO MEDIUM STONE USED FOR SURFACE. N AND E EDGES ALMOST LEVEL
- 4- SURFACE POTTED AND IRREGULAR. EDGES ELONG W/ SURROUNDING TERRAIN
- 5- 185° X 7° / SEE MAP
- 6- SLOPING TO SW
- 7- DENSE FERN AND MALT-A-MINUTE (1-1½m).
COCONUT TREES (>25m) ON SITE
- 8- EXCEPT FOR WALKWAY #155 AREA SURROUNDING PLATFORM
VOID OF CULTURAL MATERIAL
- 9- SAPAPALII VILLAGE
- 10- ?
- 11- AREA AROUND #154 POSSIBLY 'MILAE' (VILLAGE GATE)
- 12- NONE

- 1- ELEVATED WALKWAY (WALL?)
 - 2- 300 cm / 40 cm (2.5 m)
 - 3- CONSTRUCTED OF SMALL TO LARGE STONE W/ LARGE STONE ON OUTSIDE AND TOP COVERED W/ SMALL STONE (PAVING)
 - 4- DENSELY COVERED W/ FERN AND MILK-A-MINUTE ($\frac{1}{2}$ - 1 m) COCONUT TREES (> 20 m) ON WALKWAY
- SLIGHT EVIDENCE THAT WALKWAY MAY CONNECT W/ #152 ON S END, BUT WALKWAY SEEMS JUST TO LAY OUT ON N END
